Tracer Technology Provides Insight Into Leaking Trays And Entrainment

By Lowell Pless – Business Dev. Mgr – Distillation Applications
and Dave Ferguson – Business Dev. Mgr – Tracer Technology

TRU-SCAN® Field Testing and Process/Hydraulic Analysis Revealed Likely Causes of Flooding Problems in a High Pressure Depropanizer

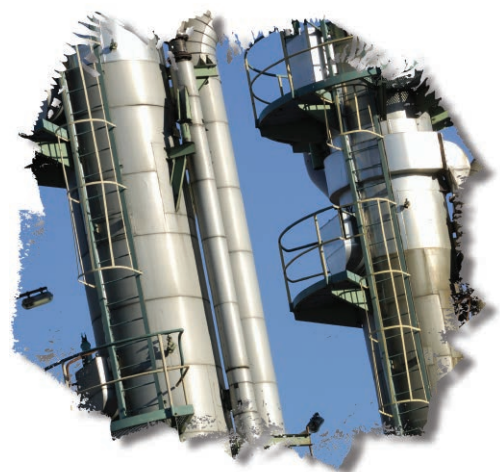
A Wash Bed tray was tested by injecting a specialist tracer into the Wash Oil feed that would not vaporize (Figure 1). The specialist tracer was selected based upon the very hot conditions encountered within the process and the instability and hence unsuitability of any organic based radio-tracer material. Detectors 1 and 2 were positioned on the Wash Oil line to measure the flow to the Wash Oil spray header. Detector 3 was on the Slop Wax

line, which is the draw from the Wash Bed tray, and was used to determine the amount of tracer that flowed from the Slop Wax draw tray. Detectors 4 and 5 on the HVGO draw line were used to confirm the flow from the HVGO draw tray. Detectors 6, 7, and 8 on the Vacuum Tower Bottoms (VTB) line were used for monitoring for the presence or absence of a leak.

Figure 1 – Illustration of detector placement

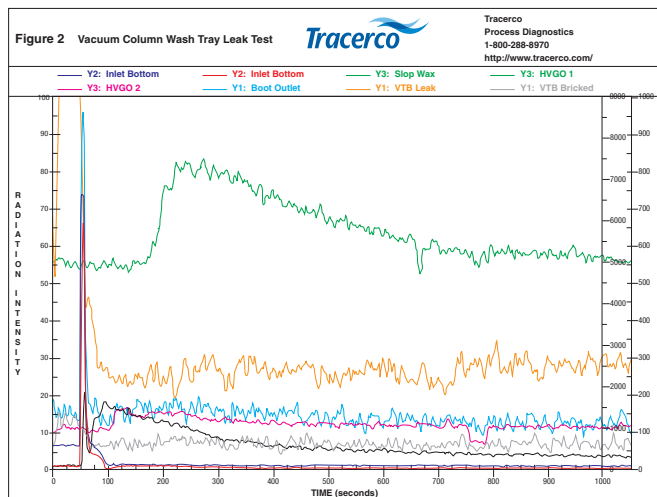
Detector response results from the first injection are illustrated in Figure 2. The responses from detectors 6, 7 and 8 on the bottoms product line (tan, light blue and grey lines) indicated that a leak was detected. A slight increase in signal was noted from the bottoms outlet and VTB line detectors, while the detector with additional shielding did not show any slight increase. This indicated that the responses of the outlet and VTB line detectors were due to

tracer that leaked into the stream and not from tracer in an adjacent line or vessel. The data confirmed that approximately 6% of the Wash Oil feed was leaking into the Vacuum Tower bottom. Approximately 41% of the tracer was carried up through the HVGO draw tray and exited through the HVGO line. (Table 1)

Figure 2 – Test results of the tan, light blue and grey line indicate a leak was found.

Confirmation of a leak and its size in the Slop Wax draw tray provided the customer the justification to plan the repair for the next shut-down. In addition, the measurement of the degree of entrainment led to ideas to improve performance of the vacuum column. The leak and entrainment study provided data that was unavailable by any other means.

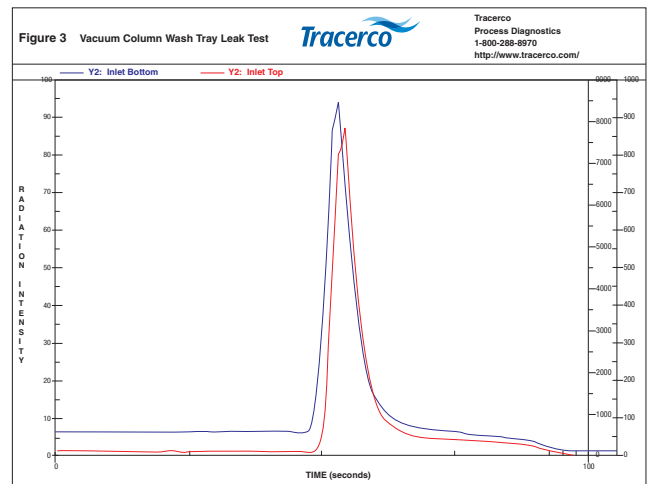
In addition to the first injection, further injections were made into the Slop Wax, HVGO and Vacuum Tower Bottoms product lines to measure flow rates. Injecting a known amount of tracer material into each of these lines allowed the leak test data to be analyzed for total flow split providing the customer with accurate fractional flow into each line, as shown in Figure 3. Flow into the Wash Oil feed line was confirmed using detectors 1 and 2. The distance between the detectors was divided by the time between the centroids of the two tracer response peaks shown in Figure 3 to calculate the velocity of the fluid at line conditions. Conversions of fluid velocities

Figure 3 – Shows the responses of the two detectors on the Wash Oil line as the tracer entered the Vacuum column.

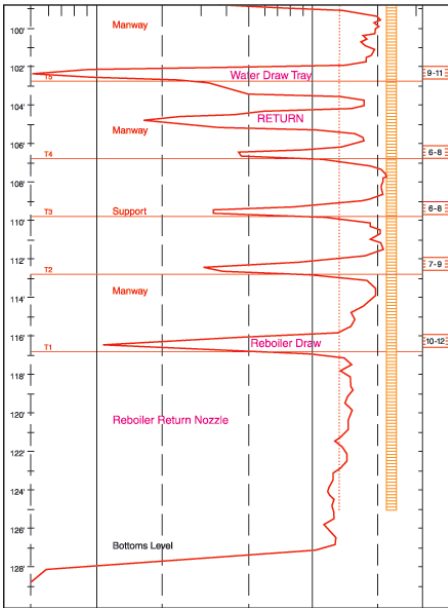
The TRU-SCAN® results (Figure 4) ruled out the possibility of significant mechanical damage or obvious process problems. In addition the results indicated that Tray 5 was holding 9 inches of liquid, well below the 14 inch vapor riser height.

Figure 4 – TRU-SCAN® results confirmed that all trays were in place, and that the liquid level on the total draw Tray 5 was not high enough to allow the liquid to overflow the risers.

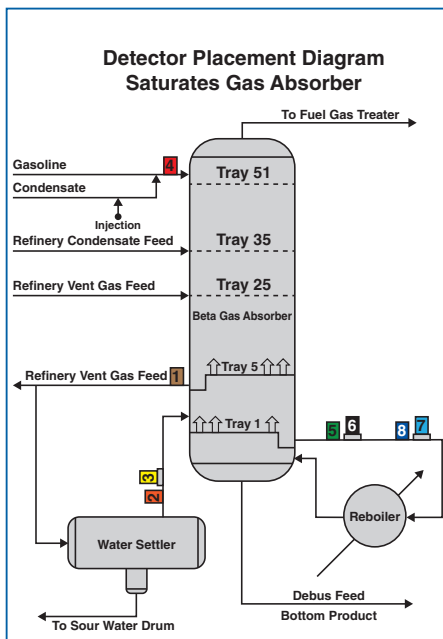
The gas absorber bottom product flows into the Debutanizer. Excessive water in the Debutanizer feed compromises its performance and can create corrosion problems in downstream equipment. There are several pathways for water to get into the Saturates Absorber bottom product. (Figure 5) These include:

- Water leaking from the total draw Tray 5
- Excessive water level on draw Tray 5, resulting in water overflowing the vapor risers
- High water level in the water settler, resulting in carryover from settler to Tray 1
- Reboiler leak introducing steam with hydrocarbon vapor below Tray 1

Figure 5 Excessive water in the Absorber bottoms not only limits debutanizer performance, but creates downstream corrosion problems.

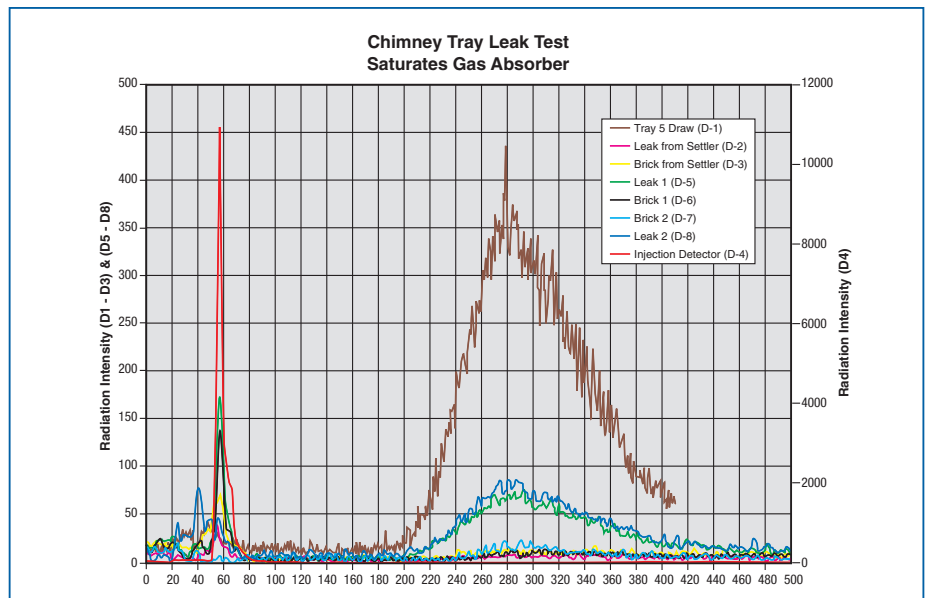
With the most likely possibilities ruled out by the scans, it was suspected that water in the bottoms product was leaking past the chimney tray (Draw Tray 5) through a faulty seal weld or fatigue crack.

Test results (Figure 6) confirmed a 4.5% leak past the chimney tray into the bottoms product. These test results matched with the results of the previous neutron test and confirmed that water from the settler was not getting back into the column.

Figure 6 – Radiotracer was injected into the condensate feed to identify the leakage mechanism that was allowing water to progress past the total draw tray. Test results confirmed a 4.5% leak past the chimney tray into the bottoms product.

As a result of the tests, the problem was precisely identified in a matter of days as opposed to weeks of trial and error. Knowing the cause and severity of the problem well in advance, the Saturates Gas Plant Absorber was shut-down and entered to discover a faulty seal

weld on the leaking draw tray. The tray was repaired and the Absorber was brought back on-line with minimal downtime.

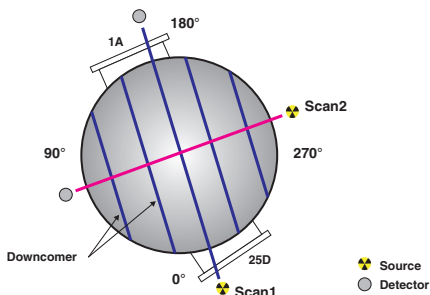
Figure 8 – Scan line orientations

To investigate the hydraulic abnormalities in the transition zone, two more TRU-SCANS® were performed, one for active areas and one for downcomers, as shown in Figure 8. Scan 1 was performed across the active area by scanning parallel to the downcomer; Scan 2 was perpendicular through the downcomer.

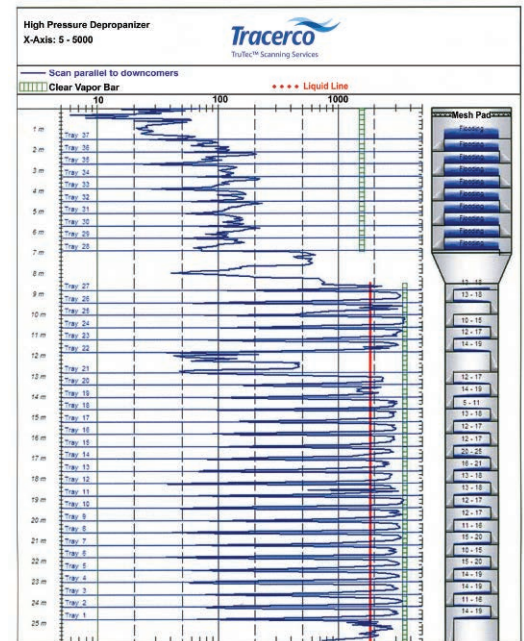
The TRU-SCAN® confirmed that the top section of the HP Depropanizer was flooding. As seen in Figure 7 the flooding started at Tray 28 indicating that the downflow liquid from Tray 28 was restricted at the transition zone. However the initial scan could not provide sufficient information to answer the questions on the root cause of flooding:

Figure 7 – Initial scan showed that flooding started at Tray 28.

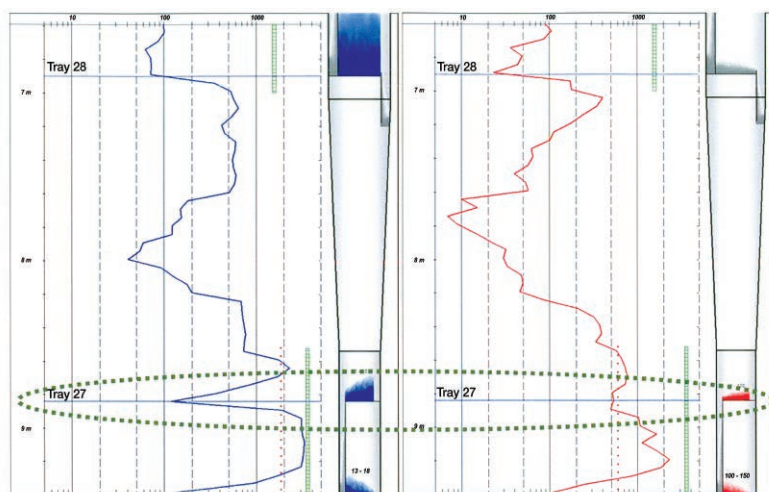
Figure 9 is an expanded view of the two scans through the transition section. While the orientation of Scan 2 was not the preferred method for investigating the hydraulic condition of Tray 28’s downcomer it did reveal some new information.

Scan 1 showed a level of aerated liquid on Tray 27 while Scan 2 showed Tray 27 operating dry, as seen in Figure 9. Within the highlighted area on Figure 9 Scan 1 (the blue curve) showed a response at Tray 27 signifying

Figure 9 – The liquid holdup or froth on Tray 27 appeared unsteady during the scans

response at Tray 27. There was no dense material i.e., no liquid holding on Tray 27. Since Tray 27 had been seen holding liquid there was no question that Tray 27 was intact mechanically. It was therefore determined to be due to a lack of liquid downflow from Tray 28 above due to a severe restriction. Reconciling this data with plant process information confirmed that as the pressure drop or flooding severity increased and was prolonged, Tray 27 dried up confirming that the downcomer from Tray 28 was indeed restricted.

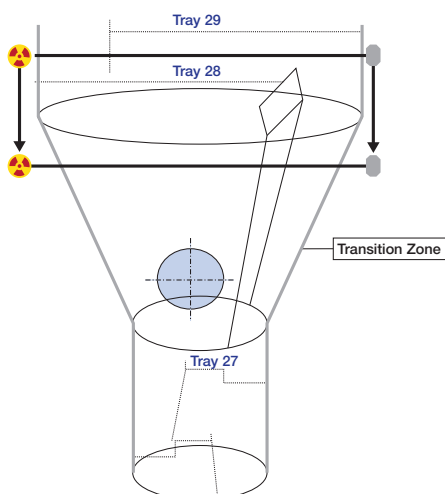
Figure 10 – The transition section imposed challenges to gamma scans

Depropanizer, top large diameter and bottom smaller diameter, is somewhat challenging for a TRU-SCAN®, as shown in Figure 10. As the gamma source and detector travel down through the transition zone, the source and detector are essentially hanging “in the air”, instead of maintaining contact against the walls. Due to limited access through the transition zone this was unavoidable on this tower. Any slight change in position can affect data gathered.

Additionally the diameter constantly changes through the transition zone. Even if it was possible to maintain the source and detector against the column wall, for each drop in elevation the radiation counts at the detector will vary based on the constantly changing diameter. It could be possible, even if improbable, that a change in internal process density would be negated or exaggerated by the change in diameter or distance from source to detector.

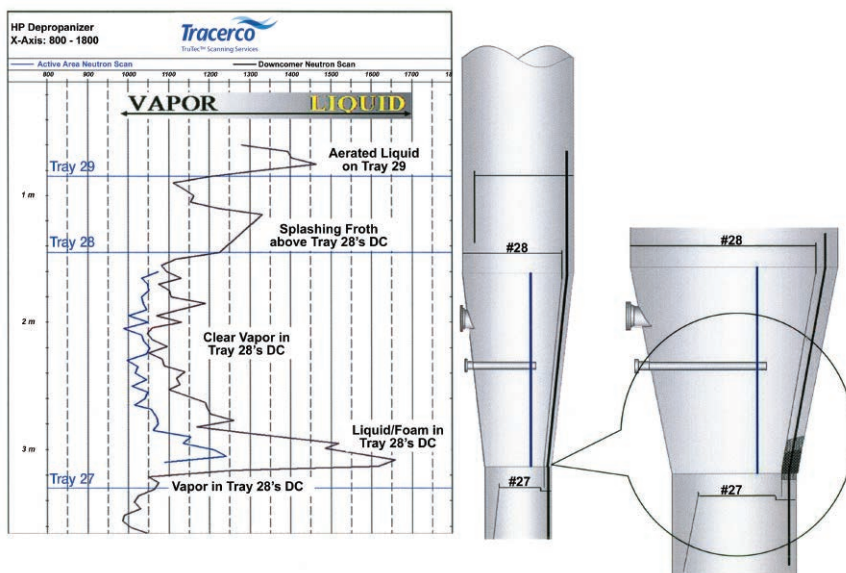
Figure 11 TruTec™ Neutron Backscatter scans of the downcomer in transition section

The TruTec™ Neutron Backscatter scan started above the opening of Tray 28’s downcomer and proceeded down to below the bottom of this downcomer. The black curve in Figure 11 shows the results from this scan. At the bottom of the downcomer where one would expect liquid the neutron response instead showed vapor. There was a “liquid” response further up in the downcomer, several centimeters from the bottom. The reasoning was that this was due to a layer of highly aerated liquid or foam suspended in the downcomer by the vapor. Furthermore, simultaneous neutron readings were taken on the active area of Tray 27 and it was seen to be void of any substantial level of liquid.

Thus the neutron scans validated the hypothesis that vapor was blowing back up the downcomer of Tray 28 and preventing liquid from down-flowing out of the top section, thus flooding the top of the HP Depropanizer.

With a clear picture of the root cause of flooding in the transition section, several steps were proposed and installed to correct the configuration of the HP Depropanizer feed zone.

After the modifications were installed, the HP Depropanizer and the unit were restarted. The unit was able to demonstrate design capacity in a successful plant test run with no further symptoms of flooding.
