Tracer Technology Provides Insight Into Leaking Trays And Entrainment

By Lowell Pless – Business Dev. Mgr – Distillation Applications and Dave Ferguson – Business Dev. Mgr – Tracer Technology

TRACERCO Diagnostics™ Tower Scan Field Testing and Process/Hydraulic Analysis Revealed Likely Causes of Flooding Problems in a High Pressure Depropaniser

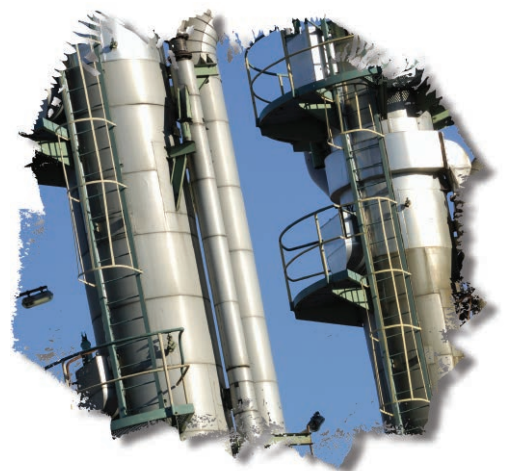
A Wash Bed tray was tested by injecting a specialist tracer into the Wash Oil feed that would not vapourise (Figure 1). The specialist tracer was selected based upon the very hot conditions encountered within the process and the instability and hence unsuitability of any organic based radiotracer material. Detectors 1 and 2 were positioned on the Wash Oil line to measure the flow to the Wash Oil spray

header. Detector 3 was on the Slop Wax line, which is the draw from the Wash Bed tray, and was used to determine the amount of tracer that flowed from the Slop Wax draw tray. Detectors 4 and 5 on the HVGO draw line were used to confirm the flow from the HVGO draw tray. Detectors 6, 7, and 8 on the Vacuum Tower Bottoms (VTB) line were used for monitoring for the presence or absence of a leak.

Figure 1 – Illustration of detector placement

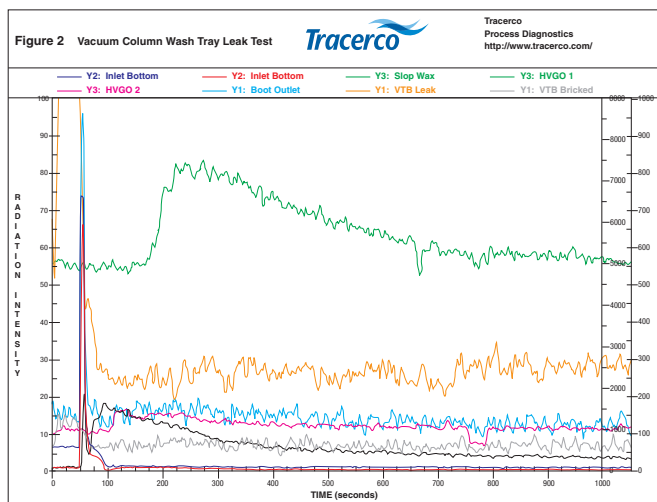
Detector response results from the first injection are illustrated in Figure 2. The responses from detectors 6, 7 and 8 on the bottoms product line (tan, light blue and grey lines) indicated that a leak was detected. A slight increase in signal was noted from the bottoms outlet and VTB line detectors, while the detector with additional shielding did not show any slight increase. This indicated that the responses of the outlet and

VTB line detectors were due to tracer that leaked into the stream and not from tracer in an adjacent line or vessel. The data confirmed that approximately 6% of the Wash Oil feed was leaking into the Vacuum Tower bottom. Approximately 41% of the tracer was carried up through the HVGO draw tray and exited through the HVGO line. (Table 1)

Figure 2 – Test results of the tan, light blue and grey line indicate a leak was found.

Confirmation of a leak and its size in the Slop Wax draw tray provided the customer the justification to plan the repair for the next shutdown. In addition, the measurement of the degree of entrainment led to ideas to improve performance of the vacuum column. The leak and entrainment study provided data that was unavailable by any other means.

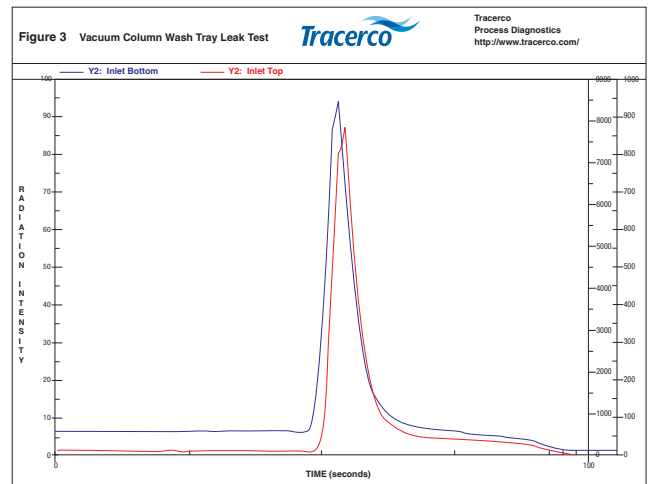
In addition to the first injection, further injections were made into the Slop Wax, HVGO and Vacuum Tower Bottoms product lines to measure flow rates. Injecting a known amount of tracer material into each of these lines allowed the leak test data to be analysed for total flow split providing the customer with accurate fractional flow into each line, as shown in Figure 3. Flow into the Wash Oil feed line was confirmed using detectors 1 and 2. The distance between the detectors was divided by the time between the centroids of the two tracer response peaks shown in Figure 3 to calculate the velocity of the fluid at line conditions. Conversions of fluid ve-

Figure 3 – Shows the responses of the two detectors on the Wash Oil line as the tracer entered the Vacuum column.

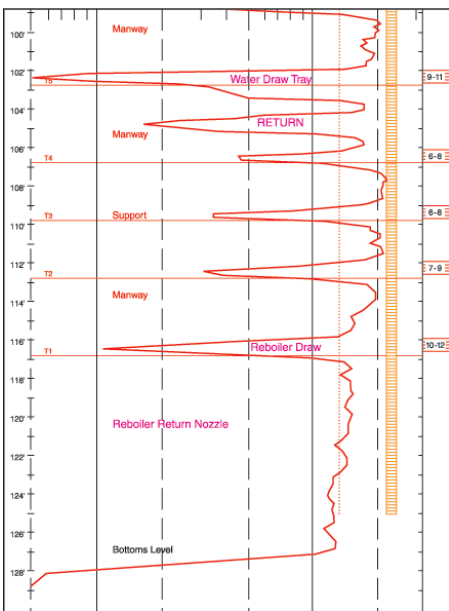
The TRACERCO Diagnostics™ Tower Scan results (Figure 4) ruled out the possibility of significant mechanical damage or obvious process problems. In addition the results indicated that Tray 5 was holding 9 inches of liquid, well below the 14 inch vapour riser height.

Figure 4 – TRACERCO Diagnostics™ Tower Scan results confirmed that all trays were in place, and that the liquid level on the total draw Tray 5 was not high enough to allow the liquid to overflow the risers.

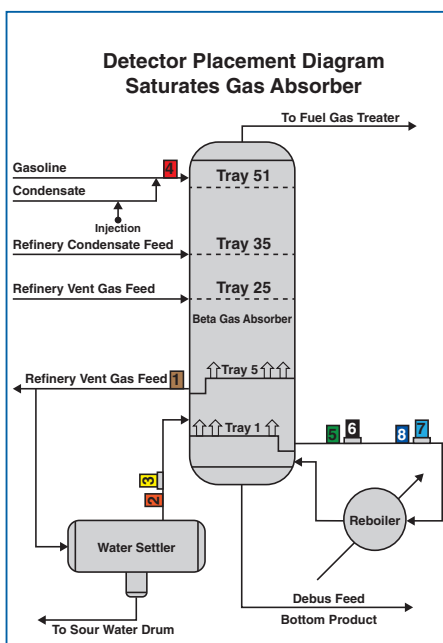
The gas absorber bottom product flows into the Debutanizer. Excessive water in the Debutanizer feed compromises it's performance and can create corrosion problems in downstream equipment. There are several pathways for water to get into the Saturates Absorber bottom product. (Figure 5) These include:

- Water leaking from the total draw Tray 5
- Excessive water level on draw Tray 5, resulting in water overflowing the vapour risers
- High water level in the water settler, resulting in carryover from settler to Tray 1
- Reboiler leak introducing steam with hydrocarbon vapour below Tray 1

Figure 5 Excessive water in the Absorber bottoms product not only limits debutanizer performance, but creates downstream corrosion problems.

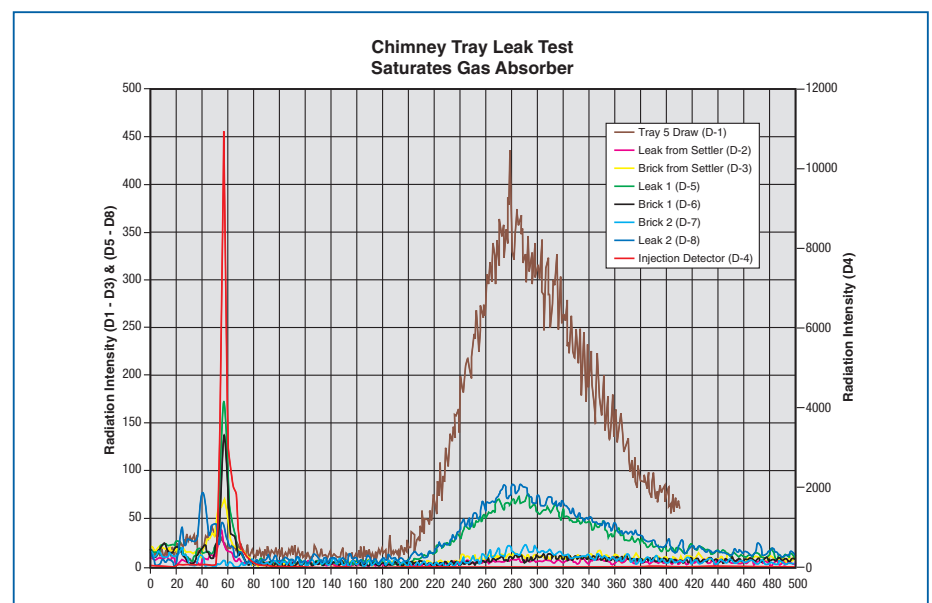
Test results (Figure 6) confirmed a 4.5% leak past the chimney tray into the bottoms product. These test results matched with the results of the previous neutron test and confirmed that water from the settler was not getting back into the column.

As a result of the tests, the problem was precisely identified in a matter of days as opposed to weeks of trial and error. Knowing the cause and severity of the problem well in advance, the Saturates Gas Plant Absorber was shutdown and entered to discover a faulty seal weld on the leaking draw tray. The tray was repaired and

Figure 6 – Radiotracer was injected into the condensate feed to identify the leakage mechanism that was allowing water to progress past the total draw tray. Test results confirmed a 4.5% leak past the chimney tray into the bottoms product.

the Absorber was brought back on-line with minimal downtime.

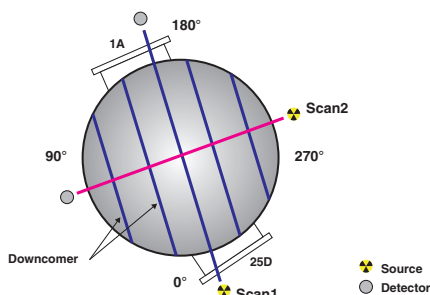
Figure 8 – Scan line orientations

To investigate the hydraulic abnormalities in the transition zone, two more TRACERCO Diagnostics™ Tower Scans were performed, one for active areas and one for downcomers, as shown in Figure 8. Scan 1 was performed across the active area by scanning parallel to the downcomer; Scan 2 was perpendicular through the downcomer.

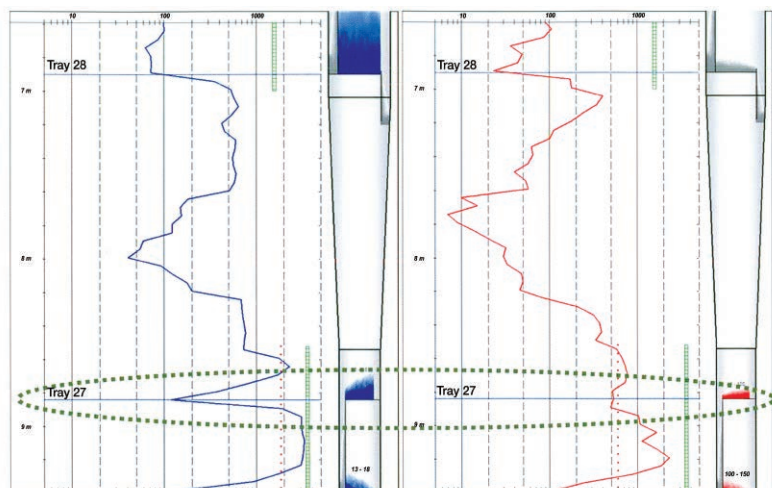
Figure 9 is an expanded view of the two scans through the transition section. While the orientation of Scan 2 was not the preferred method for investigating the hydraulic condition of Tray 28's downcomer it did reveal some new information.

Scan 1 showed a level of aerated liquid on Tray 27 while Scan 2 showed Tray 27 operating dry, as seen in Figure 9. Within the highlighted area on Figure 9 Scan 1 (the blue

curve) showed a response at Tray 27 signifying some dense material (liquid) on the active area of Tray 27. Conversely Scan 2 (red curve) (continued on page 5)

Figure 9 – The liquid holdup or froth on Tray 27 appeared unsteady during the scans

within the highlighted area showed nearly no response at Tray 27. There was no dense material i.e., no liquid holding on Tray 27. Since Tray 27 had been seen holding liquid there was no question that Tray 27 was intact mechanically. It was therefore determined to be due to a lack of liquid downflow from Tray 28 above due to a severe restriction. Reconciling this data with plant process information confirmed that as the pressure drop or flooding severity increased and was prolonged, Tray 27 dried up confirming that the downcomer from Tray 28 was indeed restricted.

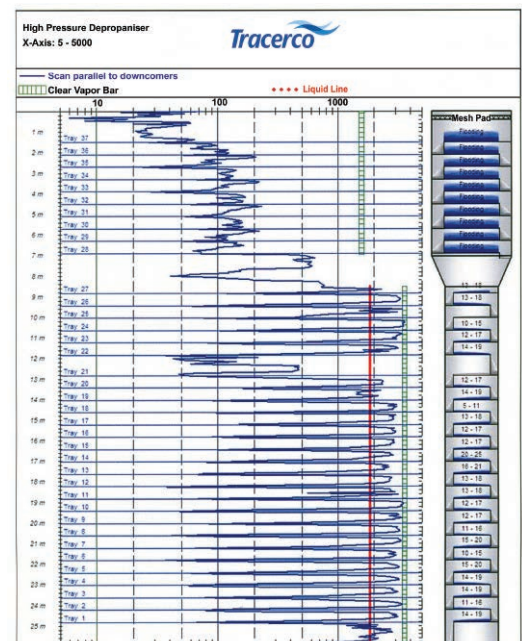
The scan confirmed that the top section of the HP Depropaniser was flooding. As seen in Figure 7 the flooding started at Tray 28 indicating that the downflow liquid from Tray 28 was restricted at the transition zone. However the initial scan could not provide sufficient information to answer the questions on the root cause of flooding:

Figure 7 – Initial scan showed that flooding started at Tray 28.

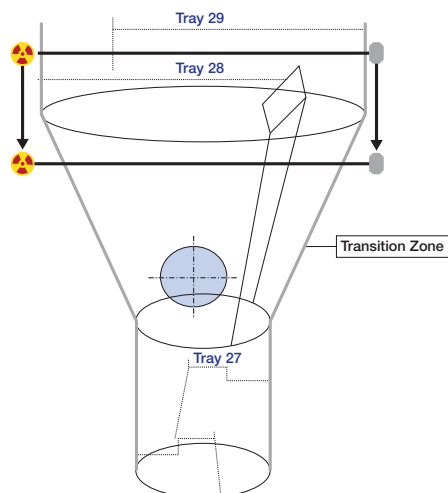
Figure 10 – The transition section imposed challenges to gamma scans

physical structure of the HP Depropaniser, top large diameter and bottom smaller diameter, is somewhat challenging for a TRACERCO Diagnostics™ Tower Scan, as shown in Figure 10. As the gamma source and detector travel down through the transition zone, the source and detector are essentially hanging "in the air", instead of maintaining contact against the walls. Due to limited access through the transition zone this was unavoidable on this tower. Any slight change in position can affect data gathered.

Additionally the diameter constantly changes through the transition zone. Even if it was possible to maintain the source and detector against the column wall, for each drop in elevation the radiation counts at the detector will vary based on the constantly changing diameter. It could be possible, even if improbable, that a change in internal process density would be negated or exaggerated by the change in diameter or distance from source to detector.

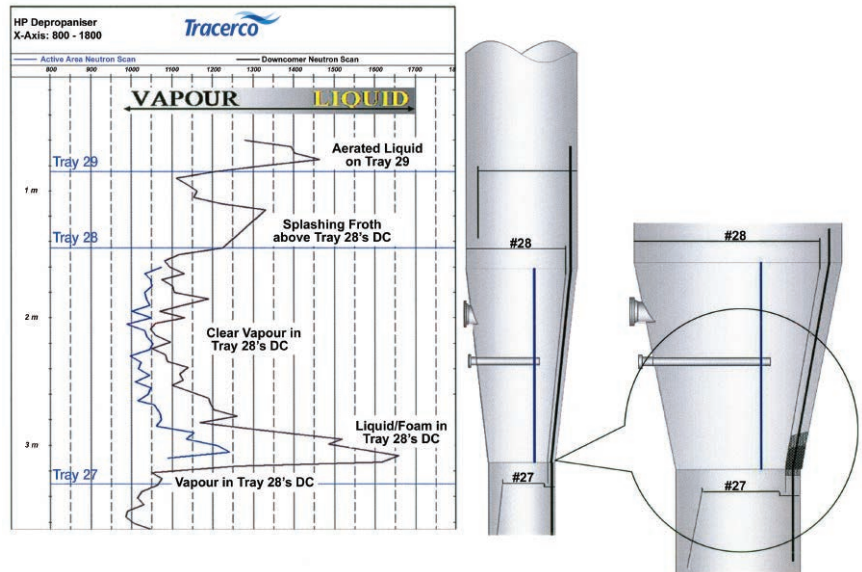
Figure 11 TRACERCO Diagnostics™ Scans of the downcomer in transition section

The scan started above the opening of Tray 28's downcomer and proceeded down to below the bottom of this downcomer. The black curve in Figure 11 shows the results from this scan. At the bottom of the downcomer where one would expect liquid the neutron response instead showed vapour. There was a "liquid" response further up in the downcomer, several centimeters from the bottom. The reasoning was that this was due to a layer of highly aerated liquid or foam suspended in the downcomer by the vapour. Furthermore, simultaneous neutron readings were taken on the active area of Tray 27 and it was seen to be void of any substantial level of liquid.

Thus the neutron scans validated the hypothesis that vapour was blowing back up the downcomer of Tray 28 and preventing liquid from down-flowing out of the top section, thus flooding the top of the HP Depropanizer.

With a clear picture of the root cause of flooding in the transition section, several steps were proposed and installed to correct the configuration of the HP Depropaniser feed zone.

After the modifications were installed, the HP Depropanizer and the unit were restarted. The unit was able to demonstrate design capacity in a successful plant test run with no further symptoms of flooding.
