# Distillation Column - Tray Damage and Flooding

## Project Field Test

A large refinery had been experiencing unacceptable performance from their depropaniser column. Tru-Scan™ results of the column scan are shown in Figure 1.

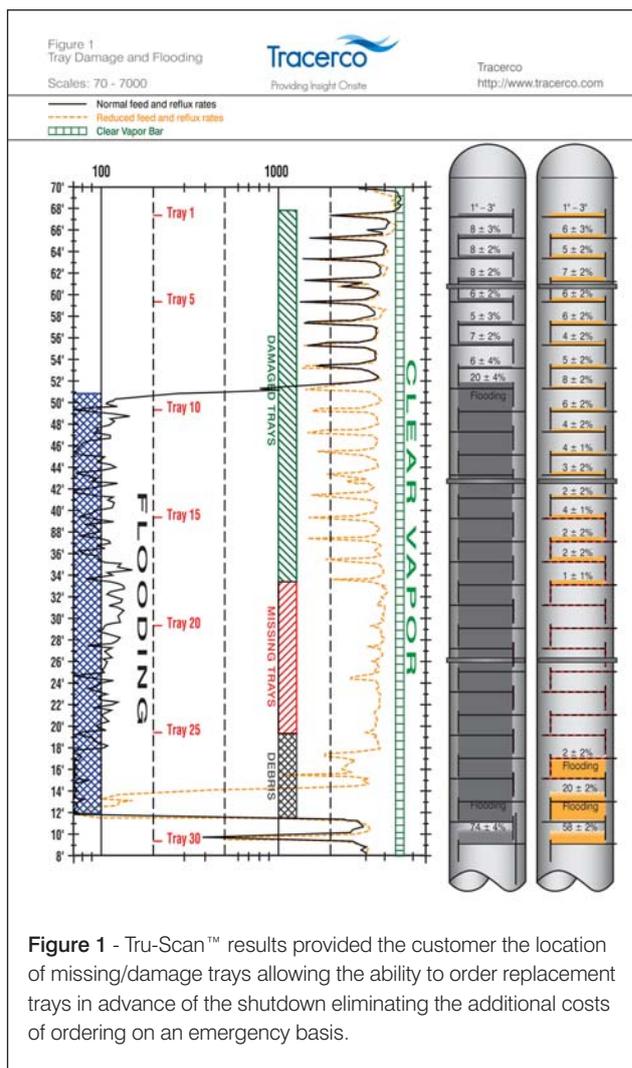
Scan results from the first scan showed Trays 1-8 were operating with very minimal froth heights (ranging from 13cm ±3% to 20cm ±3% ) and were weeping severely. Liquid back-up flooding was found, originating at Tray 29 and extending upward to Tray 10. Tray 30 was found to be in place, operating with a froth height of 188cm ±4%. Because Trays 11-29 were inundated with liquid, it was not possible to verify their placement or evaluate their ability to maintain froth.

After the plant reduced the feed and reflux rates for the second scan no significant change was found on Trays 1-8. Trays 9-18 were found to be virtually dry and weeping severely and Trays 19-25 were found to be missing. There were odd and irregular data responses found for Trays 26-29 and Tray 30 remained intact.

- Trays 1 - 18 were partially damaged and unable to sustain normal froth heights.
- Debris from Trays 19 - 28 had collected on Tray 29, restricting liquid traffic and stacking liquid from that point upward.

The customer ordered replacement trays and had them ready for a shutdown. Upon entering the column, Trays 1 - 18 were found to have severe corrosion damage. Trays 19-28 had been blown out and were found on top of Tray 29. The scans enabled the customer to order trays, plan a shutdown, and avoid the additional costs of ordering replacement equipment on an emergency basis.

Figure 1 - Tru-Scan™ results provided the customer the location of missing/damage trays allowing the ability to order replacement trays in advance of the shutdown eliminating the additional costs of ordering on an emergency basis.
