# Exchanger Leak Testing - Radiotracers

## Project Field Test

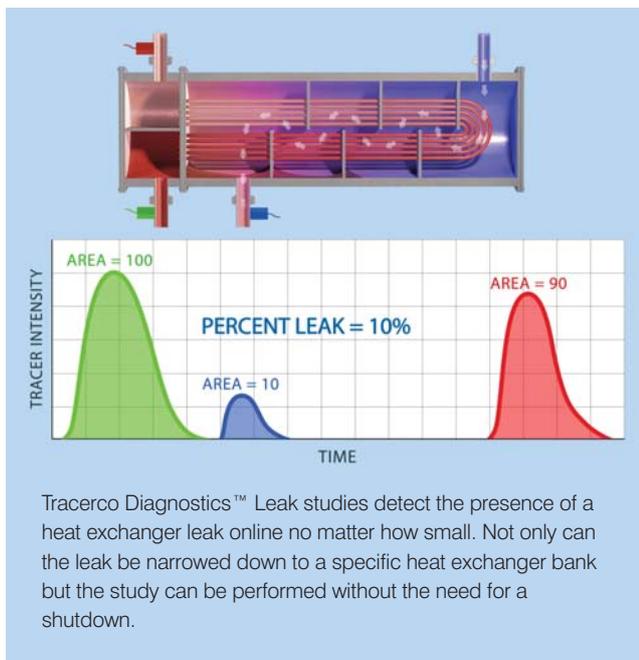
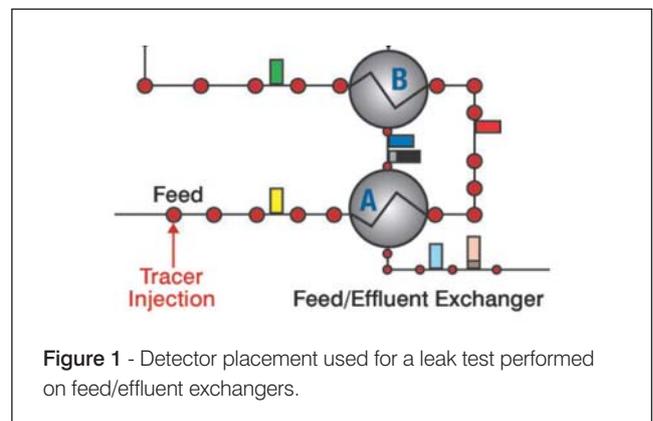
Figure 1 shows the positioning of the detectors for the leak test. Detectors mounted on the outside of the pipes will detect the radiotracer as it passes through. If radiotracer leaks into the effluent side, the detectors mounted on the effluent lines will respond to the radiotracer. However, the leak detectors on the effluent line can produce false responses from the radiotracer in the feed side of the exchangers due to radiation "shine".

To differentiate the responses, a second leak detector is mounted next to the primary leak detector. A dense material is positioned between the secondary detector and the effluent pipe. If radiotracer passes through the effluent line, the primary detector will respond, but the response of the secondary detector will be smaller or non-existent, due to the dense material blocking the radiation. If both the primary and the secondary leak detectors produce similar responses, the signal is from "shine" of the main body of radiotracer in the feed side.

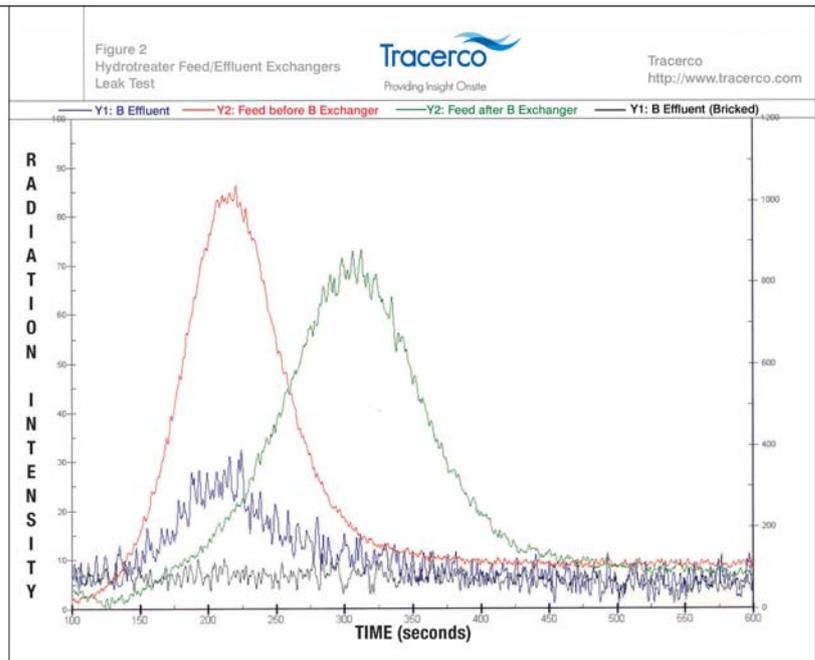
In Figure 2, the passage of the main body of radiotracer through the feed side of the B exchanger is shown by the responses of the red and green detectors. The primary leak detector (blue) also showed a response. Yet, the secondary leak detector (black) did not show a response. This indicates that the response of the blue detector was due to radiotracer in the effluent line caused by a leak in the B exchanger. The area under the response of the blue detector was compared to the area under the responses of the red and green detectors. The leak response was determined to be approximately 2.5%.

**Figure 2** - A leak was indicated from the “blue” detector response found in exchanger B. The main body of radiotracer through the feed side of the B exchanger is shown by the red and green detector response curves. A comparison of areas under the red, green and blue plot results indicated that a 2.5% leak was detected.

The refinery personnel were pleased to hear that the source of the high sulfur level was a leaking exchanger and to know which exchanger to repair. They took a short outage to repair the leak. When they restarted the plant, the sulfur levels returned to normal.
