Packed Column - Damaged Packing

Project Field Test

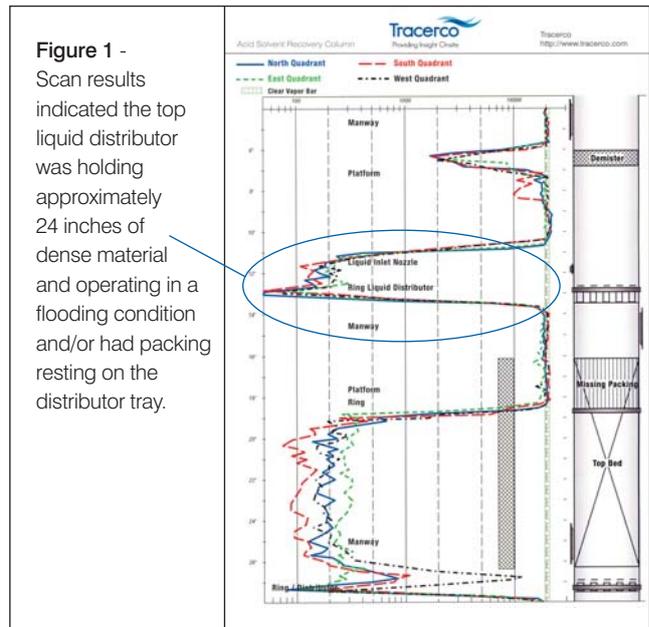
Figure 1 - Scan results indicated the top liquid distributor was holding approximately 24 inches of dense material and operating in a flooding condition and/or had packing resting on the distributor tray.

Based on the scan results (Figure 1) the top liquid distributor was shown to be holding approximately 60cm of dense material and was operating in a flooded condition and/or had packing resting on the distributor tray.

The top portion of the upper bed appeared to be missing 30" of packing which could be due to lack of packing elements installed or displaced packing that was blown up onto the top liquid distributor. This bed was also operating with poor liquid distribution with liquid channeling through the south quadrant and liquid deficiency through the east quadrant.

The space between the bottom of the top bed and the liquid distributor above the lower bed should have shown a clear vapour space if all was well with the column. Instead this space was very dense with either liquid and/or packing material, especially in the eastern quadrant of the column. This could indicate a breach in the eastern portion of the top bed support that would have caused packing to collapse onto the distributor.

After reviewing the scan results the customer entered the column a few weeks after the scan to make repairs. They found that the top bed hold down plate was missing so packing from the top bed had been carried up onto the top liquid distributor. This caused the top distributor to appear flooded. The top hold down grid for the top bed was found buried in the lower portion of the packing. The bottom support grid for the top bed was still in place so no packing from the top bed had collapsed onto the bottom liquid distributor.

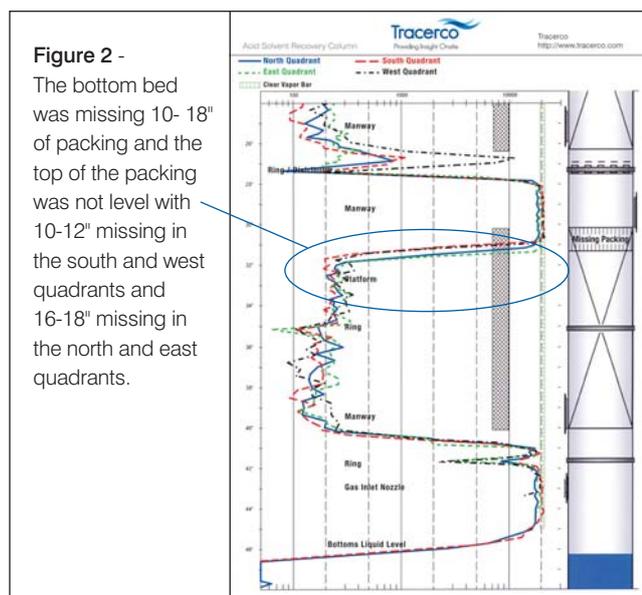
The top portion of the bottom bed appeared to have 25-46cm of packing missing and the top of the packing was uneven with 25-30cm missing in the south and west quadrants and 41-46cm missing in the north and east quadrants (Figure 2). This missing material could indicate displaced packing that could have been blown up onto the bottom liquid distributor. The bed was also operating with a slight density gradient with denser material in the lower portion compared to the top indicating crushed or settled packing or fouling in the lower portion of the bed. The liquid distribution through this bed was fair-to-good in the top half but was worse in the bottom half of the bed.

Like the top bed, the hold down plate for the bottom bed was not in place so packing had carried up from the bottom bed onto the bottom liquid distributor. This accounted for the high density in the vapour space between the top bed and the bottom liquid distributor instead of a top bed collapse. The hold down grid for the bottom bed was buried in an almost vertical position in the lower portion of the packing.

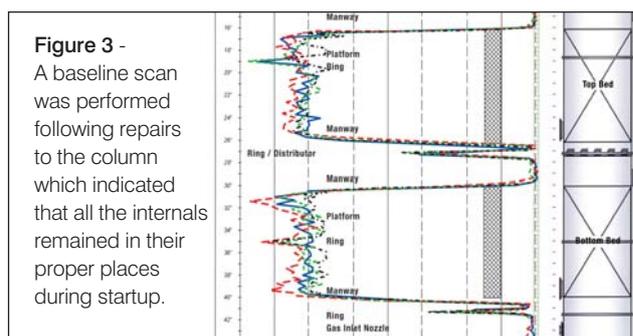
After all repairs were complete and the column restarted, the customer requested a baseline scan. The baseline scan results can be viewed in Figure 3. The baseline scan indicated that all internals remained in their proper places during startup and both beds were operating with fairly good liquid distribution. The baseline information will provide invaluable reference data for future troubleshooting scans.
