Packed Column - Distribution

Project Field Test

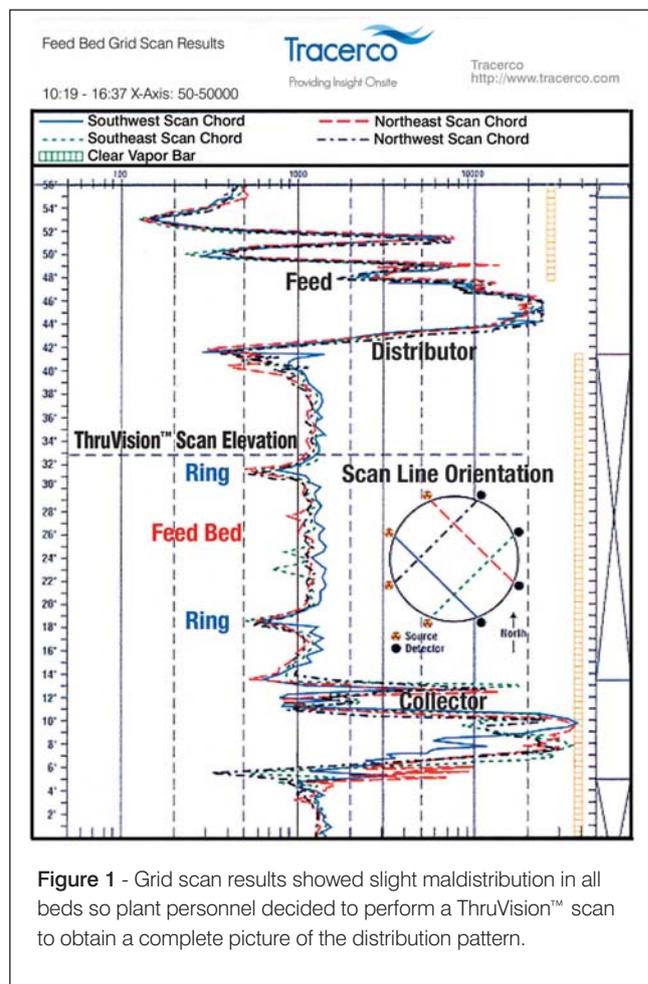
Figure 1 - Grid scan results showed slight maldistribution in all beds so plant personnel decided to perform a ThruVision™ scan to obtain a complete picture of the distribution pattern.

In order to help diagnose the cause of the problem, Tracerco was called. The first step was to perform a Tru-Grid™ Scan of this tower. The results of the grid scan showed that all distributors, collectors, and packed beds were in place with no evidence of mechanical damage. (Figure 1) The grid scan also showed slight liquid maldistribution in all of the beds, but it did not appear severe enough to cause the very poor efficiency of the tower. Liquid maldistribution had been strongly suspected and since the Tru-Grid™ Scan indicated that maldistribution could be an issue, plant personnel wanted to get as complete a picture of the distribution pattern as possible. In order to obtain a more detailed liquid distribution profile a ThruVision™ Scan was performed. The most advantageous place to perform a ThruVision™ Scan is as near the top of the bed as possible (shown in Figure 1).

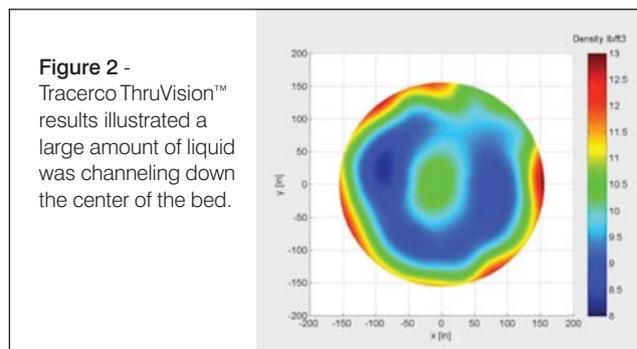
The Tracerco ThruVision™ Scan results (Figure 2) showed that a large amount of liquid was channeling down through the centre of the bed. This was not detected by a Tru-Grid™ Scan due to its pattern as all chords showed similar density profiles. This confirmed that a liquid maldistribution problem, rather than poor packing performance, was the cause of the efficiency reduction in the tower.

With the information provided by the Tracerco scans, plant personnel decided to shut down the tower and inspect the liquid distributors. Upon inspection, an error in distributor installation was discovered. This error was causing a large portion of the liquid to channel down the center of the packing. The problem was corrected, and the tower was restarted without incident. The tower was pushed to maximum design rates, and the desired separation efficiency of the new packing was achieved.
