Cost Effective Methods Used For Monitoring Flare and Other Piping Systems

By Lowell Pless, *Business Development Mgr – Distillation Applications* and Justin Tippit, *Senior Technical Specialist*

Vol 3 Ed 3

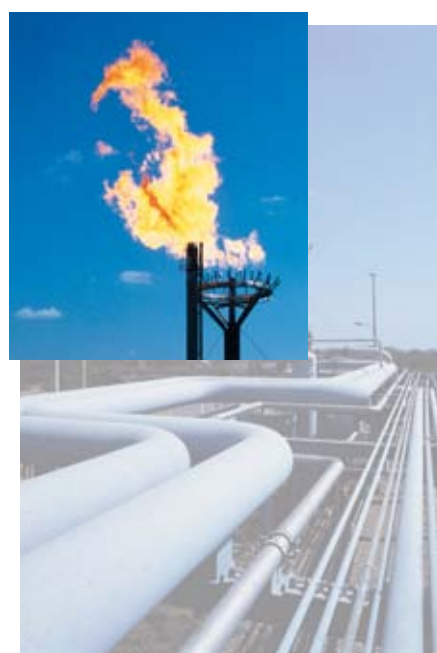
In this specific refinery, natural gas is added to the flare sub-headers to ensure continuous flow. This is commonly known as sweep gas and can be costly when not regulated properly. Flow rate analysis of the sub-header in the Crude/SRU/SCOT Tail Gas Units found the sweep gas to be 1,400 standard cubic metres per day higher than necessary with the cause of the problem found to be a failure to re-install a restriction flow orifice in the sweep gas line following a turnaround.

was determined that the overall flow from the Crude/SRU/SCOT Tail Gas was 6,200 standard cubic metres per day that was considered to be abnormally high. After reporting the results to the customer and looking at possible causes for this high flow rate operators closed the nitrogen purge to an offline compressor to examine its contribution to the flare. Subsequent flow rate measurement showed a dramatic decrease of 4,600 standard cubic metres per day. It was determined that the process valve for the nitrogen purge was open more than necessary to maintain purging of the compressor.

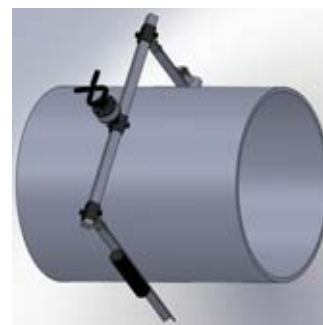
Figure 4 – Example of Pipe Scan Set-up

A TRACERCO Diagnostics™ Scan is a well-established technique that can determine both the location and depth of solid deposits. It is performed by placing a yoke assembly across the pipe under investigation at a number of lateral positions. The yoke is constructed to maintain the scan source and detector in a fixed orientation so the radiation beam passes through the mid-section of the pipe from the source to the detector, allowing for consistent data readings. (Figure 4) The yoke system is then passed down the pipe with readings being taken in select, small increments. If the density of solids is known readings can be further analysed to provide total depth of material to establish the severity of the blockage. Figure 5 is an example of the information provided from a

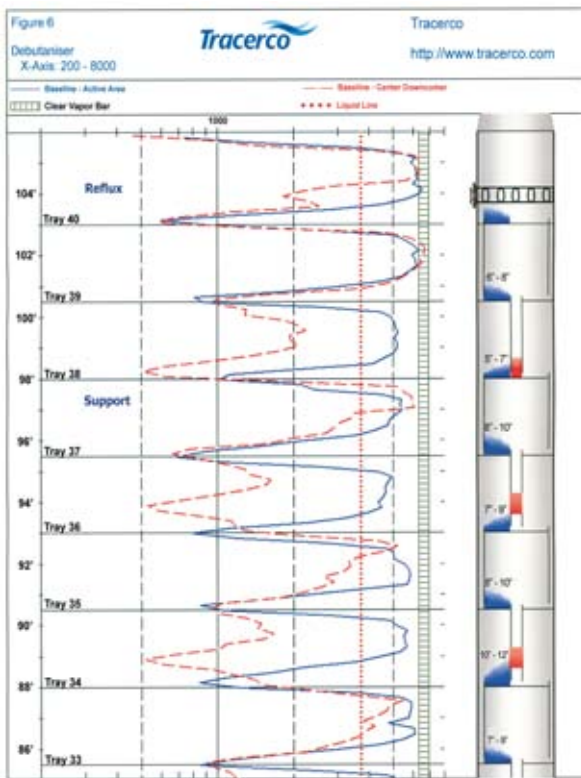
Figure 6 – The first scan of the Debutaniser revealed that the top centre downcomer below Tray 39 looked normal, but the rest of the centre downcomers had the layer of more dense, less aerated liquid suspended in the middle rather than in the bottom of the downcomer.

A baseline was established at current operating conditions by carrying out two TRACERCO Diagnostics™ Scans — one active area and one through the centre downcomers. The

results are presented in Figure 6. The active area scan did not reveal anything remarkable about the tray hydraulics. The tray active areas held reasonable levels of liquid and their vapour spaces were relatively clear. However, the centre downcomer scan showed a very interesting phenomenon. The top centre downcomer, below Tray 39, looked normal. But the data showed that the rest of the centre downcomers had a layer of more dense, less aerated liquid suspended in the middle rather than at the bottom of the downcomer. In addition, the scan showed that there was some frothing material above these centre downcomers. Remarkably, it appeared that vapour was

bypassing through the centre downcomers as there was no liquid seal at the bottom of these. Apparently this vapour bypass was enough of a separation efficiency loss to cause the slightly off-specification overhead flow.
