## Cost Effective Methods Used For Monitoring Flare and Other Piping Systems

By Lowell Pless, Business Development Mgr – Distillation Applications and Justin Tippit, Senior Technical Specialist

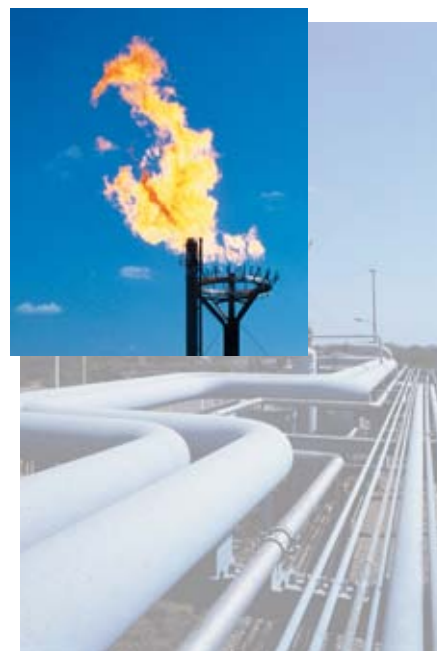
Figure 1 – Flow rate data revealed substantial portions coming from four specific tie-ins with the largest contributor being the Crude and SRU/SCOT Tail Gas Units. Further investigation was carried out within these units to identify the sources of the flow.

Flow rate data was collected from each unit sub-header to the main flare header. The data revealed substantial portions coming from four specific tie-ins with the largest contributor being the Crude and SRU/SCOT Tail Gas Units. (Figure 1, page 2) Further investigation was carried out within these units to identify the sources of the flow.

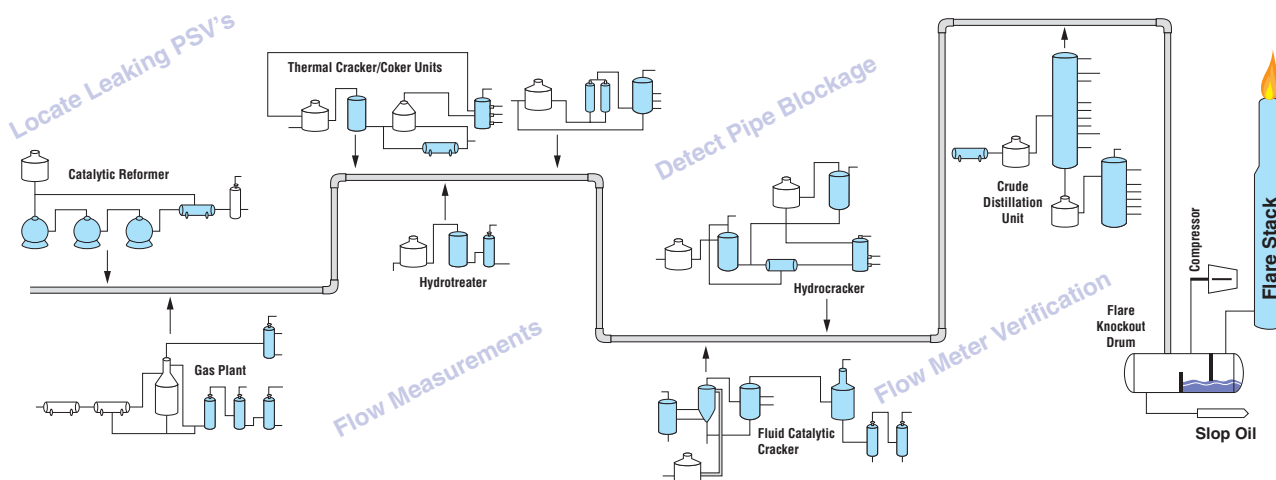
Figure 2 – Leakage past block valves or pressure safety valves is confirmed by injecting a tracer upstream and locating detectors downstream of a suspected cross-over point. If two detectors are used upstream and downstream of the cross-over point, velocities and flowrates can be determined. V1 and V2 are compared to determine the size of the leak.

In the example shown in Figure 2 tracer is injected into a process pipe or piece of equipment. If the pressure relief device is leaking then

some proportion of tracer will be detected downstream of the pressure relief device. Alternatively if an injection point is available on the downstream side of a pressure relief device; the tracer can be injected and if it remains stationary there is no flow through that pressure relief device. Conversely if the tracer is swept away due to flow coming through the pressure relief device, leakage is confirmed. Its' velocity will allow volumetric flow to be determined. Another option is to use the "flare flow" technique. Tracer is injected into a pipe with radiation detectors placed at pipe

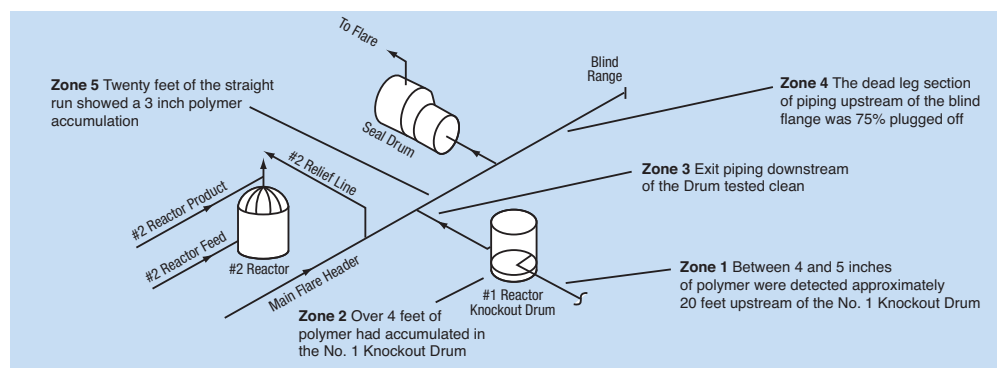
Figure 3 – Illustrates results of the Tracerco TruTec™ Neutron Backscatter surveys where fouling was found in several key areas.

One major chemical manufacturer's flare line was showing an abnormally high pressure drop in its relief piping. Tracerco was asked to survey the line that extended for hundreds of feet to determine the location and extent of a blockage. Figure 3 shows an isometric of the flare line system.

The first survey carried out, which was in increments of several feet, identified localized fouling and blockage in several key areas. Following the first series of neutron measurements, the suspect areas were scrutinized in smaller increments to assess the extent of the fouling. The system was then shutdown for maintenance. During the shutdown, fittings were installed on the piping in Zones 4 and 5, to allow access for specially designed hydroblast lances. Following a cleaning program of the system, polymer debris was removed from the No. 1 Knockout and Seal Drums. The blast taps were then plugged off using standard 3/4 inch NPT fittings and the system was brought back on-line. Subsequent pressure drop and TruTec™ Neutron Backscatter measurements confirmed that the problem had been resolved.

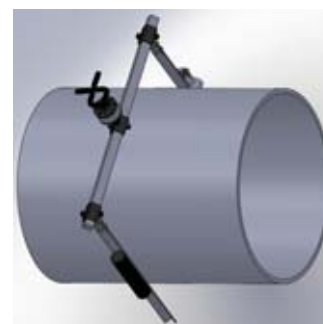
Figure 4 – Example of Pipe Scan Set-up

A TruTec™ Pipe Scan is a well-established technique that can determine both the location and depth of solid deposits. It is performed by placing a yoke assembly across the pipe under investigation at a number of lateral positions. The yoke is constructed to maintain the scan source and detector in a fixed orientation so the radiation beam passes through the mid-section of the pipe from the source to the detector, allowing for consistent data readings. (Figure 4) The yoke system is then passed down the pipe with readings being taken in select, small increments. If the density of solids is known readings can be further

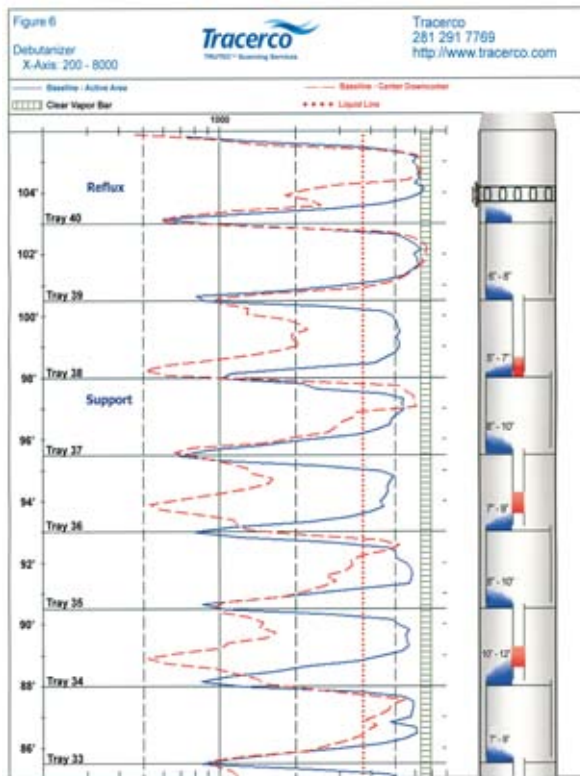
Figure 6 – The first scan of the Debutanizer revealed that the top center downcomer below Tray 39 looked normal, but the rest of the center downcomers had the layer of more dense, less aerated liquid suspended in the middle rather than in the bottom of the downcomer.

A baseline was established at current operating conditions by carrying out two TRU-SCANS® – one active area and one through the center downcomers. The results

are presented in Figure 6. The active area scan did not reveal anything remarkable about the tray hydraulics. The tray active areas held reasonable levels of liquid and their vapor spaces were relatively clear. However, the center downcomer TRU-SCAN® showed a very interesting phenomenon. The top center downcomer, below Tray 39, looked normal. But the data showed that the rest of the center downcomers had a layer of more dense, less aerated liquid suspended in the middle rather than at the bottom of the downcomer. In addition, the scan showed that there was some frothing material above these center downcomers. Remarkably, it appeared that vapor was

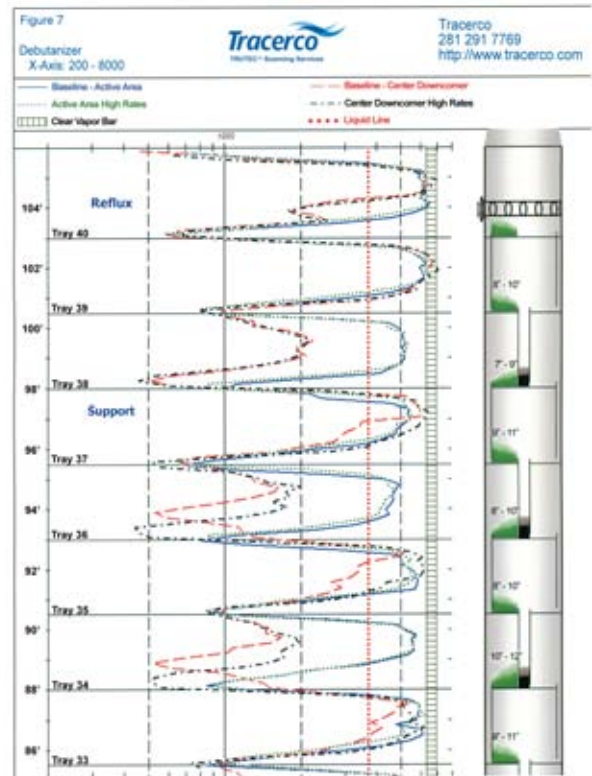
Figure 7 – After an increase in the reflux flow, the second scans showed that the layer of denser, non-aerated liquid was located at the bottom of the downcomer providing a liquid seal as should be. The downcomer scan showed a problem, easily remedied by a change in operating procedures and assisted operations in their decision on revamping the column.

The results from the second set of scans, along with the baseline scans, are shown in Figure 7. First there was no

observable change in the operation of the tray active areas. Next, a layer of denser, non-aerated liquid was located at the bottom of the downcomer providing a liquid seal as should be. Also, the froth material above the center downcomers was gone without the vapor bypassing through the center downcomers.

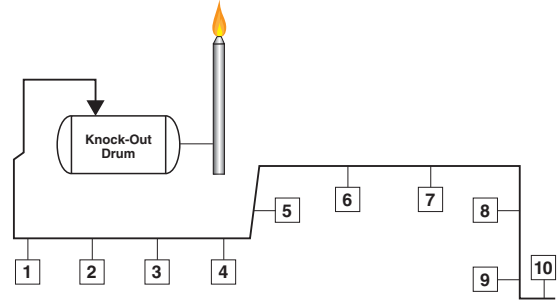
Figure 5 – A routine pipe scan program on a regular basis can determine the average build-up of deposits. A scan orientation and results spreadsheet is provided to customers.

analyzed to provide total depth of material to establish the severity of the blockage. Figure 5 is an example of the information provided from a TruTec™ Pipe Scan.
