Avoid unnecessary costs by understanding process problems before taking action

By Dave Ferguson – Operations Manager – Process Diagnostics, Pasadena TX

Inside this Issue...

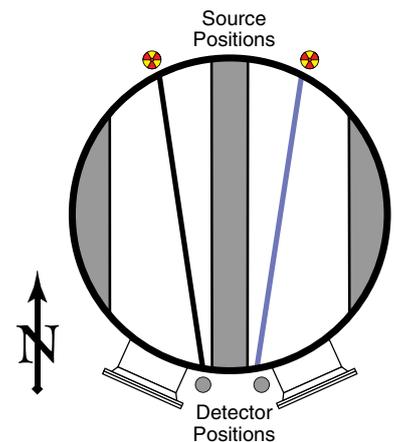
A Tru-Scan™ is performed by positioning a source on one side of a column at the top tangent line and a sensitive detector on the opposite side at the same elevation as shown in the orientation drawing in Figure 1. The scan line through the column does not have to be across a full diameter, but can be across a chord. The chord length does need to be consistent from the top of the column to the bottom. The chord is chosen such that the scan line is across an active area of the trays, avoiding the downcomers. A purposeful scan along the downcomers can also be performed to gain additional operational information, but the tray active area scan is normally performed and analyzed first.

Figure 1 – Scan line orientations for a two-pass tray arrangement.

operating normally. The orientations of the two scans in this case study are shown in Figure 1.

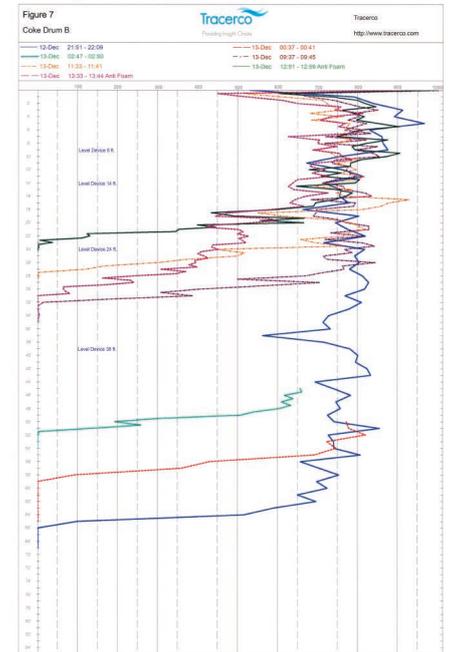
Results of Coke Drum B	Rise (feet) of Dense Material	Dense Material Below Top Tangent (feet)
Baseline Scan		65 ft.
2nd Scan - 2 hours later	10 ft.	56 ft.
3rd Scan - 2.5 hours after 2nd scan	7 ft.	49 ft.
4th Scan - 7 hours later	19 ft.	30 ft.
5th Scan - 2 hours later	25 ft.	24 ft.
6th Scan - 1 hour later-after antifoam	29 ft.	20 ft.
Final Scan - 1 hour later	21 ft.	28 ft.

Figure 7 – Results of the final scan indicated that the antifoam had knocked the level down by approximately 8 ft.

A Tracerco customer requested a Coke Drum Optimisation study be performed on their A and B coke drums to determine foam heights and verify the accuracy of their level devices. They also wanted to determine the effectiveness of their current antifoam system. Coke drums A and B were scanned (Figures 6 and 7) at various times before, during and after the switch to verify the coke level changes during the cycle. Tru-Scan™ results for coke drums A and B are shown as tables below Figures 6 and 7.

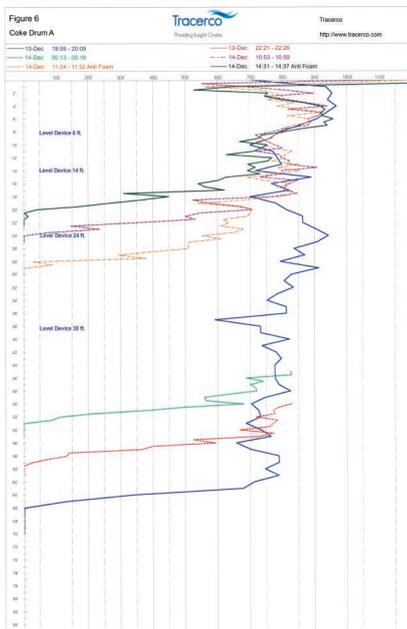
Results of Coke Drum A	Rise (feet) of Dense Material	Dense Material Below Top Tangent (feet)
Baseline Scan		64 ft.
2nd Scan - 2.5 hours later	8 ft.	56 ft.
3rd Scan - 2 hours after 2nd scan	16 ft.	50 ft.
4th Scan - 10 hours later	42 ft.	22 ft.
5th Scan - 2 hours later-after antifoam	38 ft.	26 ft.
Final Scan - 3 hours later	49 ft.	17 ft.

Figure 6 – Results of the final scan indicated an increase of dense material of 11 ft.

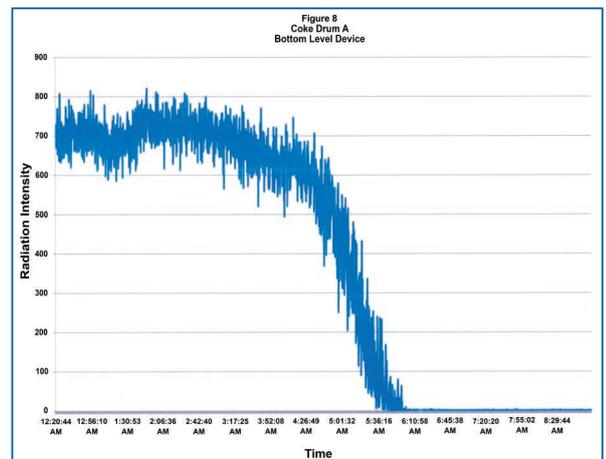
Figure 8 – Stationary monitoring scan result of one of the scans performed at the elevation of the bottom nuclear level device on Coke Drum A where the foam front was advancing as evidenced in the reduction in the count rate.

Stationary monitoring scans were performed on drums A and B at each elevation where a nuclear level device was installed. Scan results at each location provided the dates, times, radiation intensity count rates, the presence of foam and when antifoam was introduced. These time studies were used to determine density versus time to establish the sensitivity of the level indicating devices. Figure 8 shows the results of one of the stationary monitoring scans performed at the elevation of the bottom nuclear level device on Coke Drum A where the foam front was advancing as evidenced in the reduction in the count rate. Figure 9 shows the results from Coke Drum B where the foam receded after the antifoam injection.

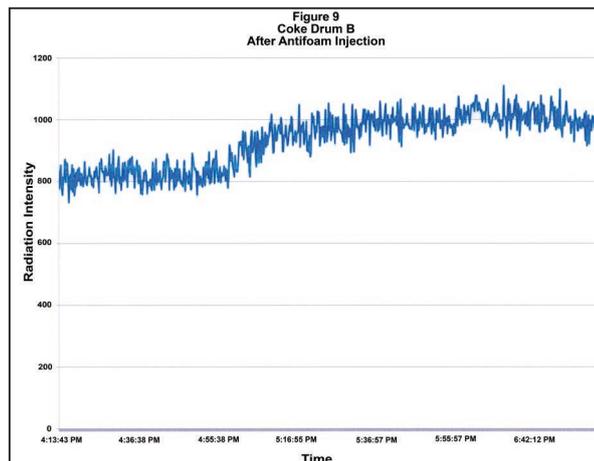
Figure 9 – Results from Coke Drum B where the foam receded after the antifoam injection.

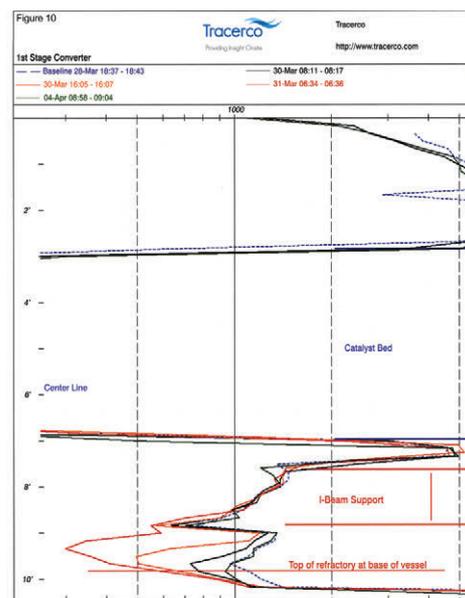
Figure 10 – Scan results monitoring the level of SRU reactor catalyst bed during a wash procedure.

used to obtain baseline data (blue dashed scanline in Figure 10) and to verify that the catalyst bed was in its proper place. As the catalyst wash began three additional scans were performed that indicated no liquid sulfur accumulation.

The following day six additional scans were completed but still no indication of accumulated liquid. On Day 3 the results of the scans showed the density in the bottom of the reactor had increased, signifying the presence of accumulated liquid. (black solid scanline in Figure 10) The reactor level was monitored throughout the day at one hour intervals revealing that the liquid level rose slowly but steadily over the course of the day. The orange solid scanline in Figure 10 was final scan done on Day 3.

Early on the morning of Day 4 the reactor was scanned showing the liquid level had risen to the bottom of the I-Beam support for the catalyst bed. This was the highest liquid level observed (red solid scanline). At this point the washing of the catalyst bed had been completed and further scans performed were used to monitor the liquid level receding. The reactor was scanned two more times after the completion of the wash on Day 5 with each scan indicating a continuing drop in the liquid level.

The final scan performed on Day 8 (green solid scanline) indicated that the reactor had returned to the baseline condition.

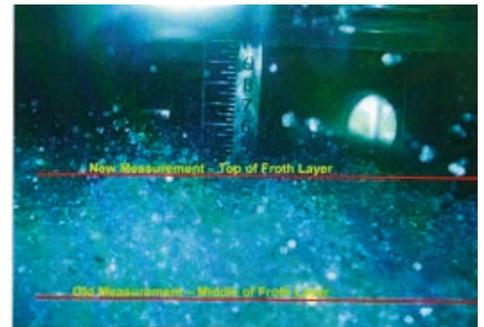
Tracerco reports the performance of the tray as % Froth Height, known as FrothView™ using patented technology. Using the slope of the line defined by the maximum density above the tray and the majority of the data points showing a decrease in the aerated liquid density of the froth, the % Froth Height is the height of froth divided by the available tray spacing. Experiments in a test column with glass windows showed that such a measurement agrees very well with simulation programs that calculate Percent Flood. (Figure 3)

Figure 3 – Pilot plant studies confirm that the median “liquid level” was measuring the level about half-way into the froth layer.

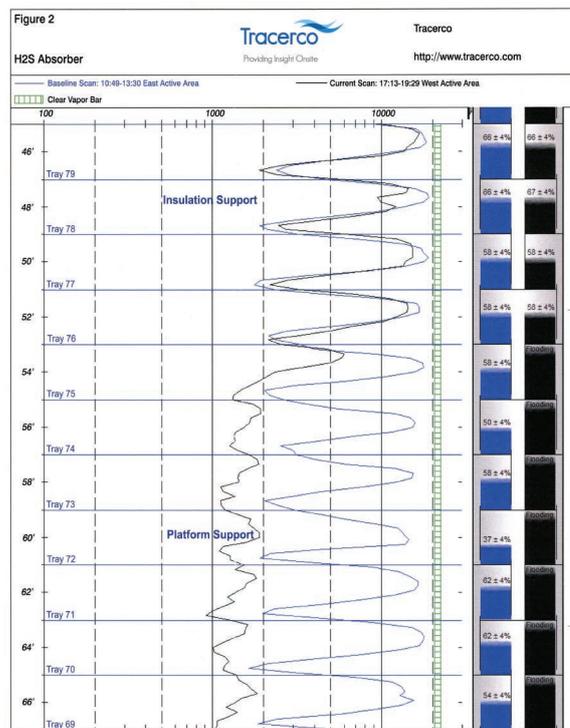
above the trays, where the average density of the aerated liquid is highest, the liquid absorbs most of the signal. The Tru-Scan™ results are then provided in a plot of the measured signal counts versus elevation (Figure 2). This plot can be interpreted to indicate the state of operation on each tray in the column.

Figure 2 shows only the section of the column from Tray 79 to Tray 69. The Y-axis is the elevation axis where 0 elevation was the top tangent line and the distance down the column is displayed on the axis. The X-axis is the measured signal and is displayed in a log scale. Low counts are on the left and high counts are on the right. The counts are inversely proportional to the density of the material the signal is passing through. High counts, on the right, are an indication of low material density and low counts, on the left, indicates high material density.

The blue scan line in Figure 2 was the baseline scan and the black scan line was the recent scan with the Absorber having high ΔP. As the blue (baseline) scan drops below Tray 79 at the top of the Figure 2, the counts head toward a maximum reading (low material density or clear vapour). The minimum reading above Tray 79 occurs at the 14.22m (46 ft, 8 in) mark where the aerated liquid on the tray was the densest. The tray decks themselves are very thin and the signal detector is 5 cm (2 in) tall, so the metal of the tray does not absorb nearly as much of the signal as the aerated liquid. This is

Figure 2 – Radiation intensity (density) profiles for normal and flooded operating conditions

The baseline scan showed that Tray 79 had a % Froth Height of 66%. The baseline scan showed that Trays 79 through 69 had % Froth heights of 50 to 66%, except for Tray 72. The scan of Tray 72, however, suffered from interference from a platform support. The scan indicated the tray was present and holding liquid, but the profile was skewed by the interference of the external structure, so the % Froth Height value was suspect.

When the Absorber was scanned with the high ΔP, Trays 79 through 76 had very similar profiles, but Trays 75 through 69 had very different profiles (black scan line in Figure 2). For Trays 74 through 69, the minimum density above each tray was now greater than the maximum aerated liquid density during the baseline scans. This indicated that these trays were liquid stack flooded. The scan of the rest of the column showed liquid stacking flooding originating at Tray 49, with higher than normal % Froth heights on Trays 48 through 1.

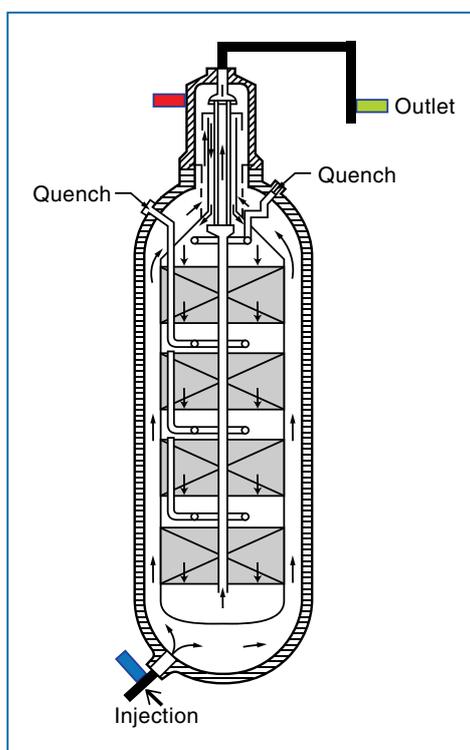
The approach Tracerco took was to position one detector on the inlet to the converter, a second detector near the top of the internal heat exchanger, and the third detector on the overhead line some 18m (60 ft) from the top of the internal exchanger. See Figure 4 on page 6.

Figure 4 – Detector placement for leak test of ammonia converter baskets and internal heat exchanger.

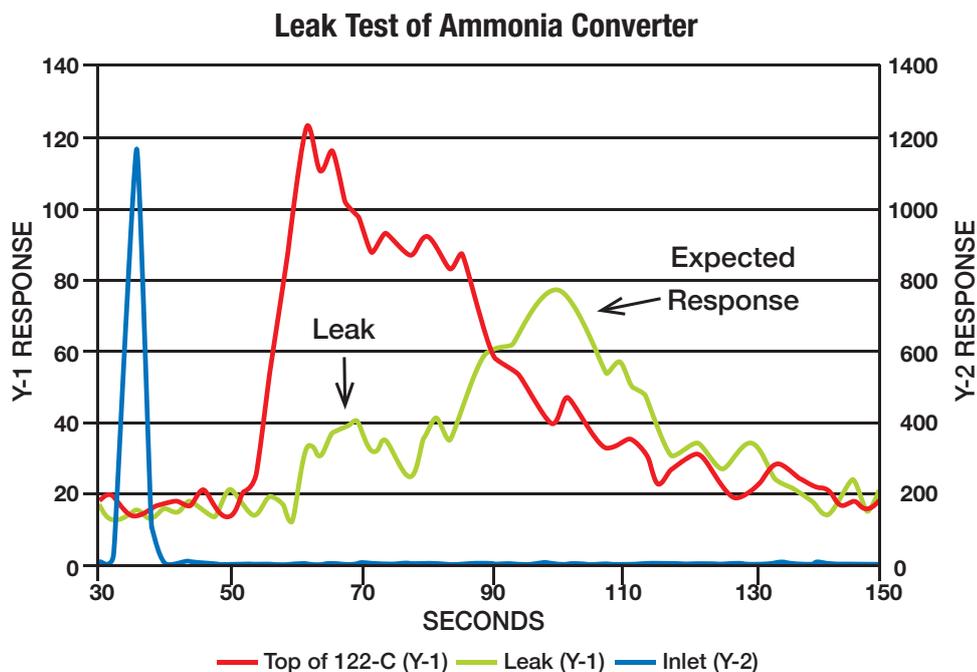
A gas tracer was injected into the feed to the converter without affecting product quality. See Figure 5 for the responses of the detectors to the tracer flowing through the converter. The injection was evident by the blue response near the 37 second mark. The tracer reached the

top of the internal exchanger at the 53 second mark, peaking at 63 seconds, as shown by the red response.

The normal path of the gas and tracer is to flow through the catalyst beds and then come back by the detector at the top of the internal exchanger as it exits the converter and goes past the third detector mounted on the overhead line. Since the tracer made the turn at the top of the internal exchanger in the annular space, the tracer was near the detector and produced a large response. At the same time, the 63 second mark, the third detector showed a response to some tracer, as seen in the green

response. This was tracer that leaked into the exit stream. The main body of tracer followed the normal path and started producing a second response from the third detector at the 87 second mark.

Figure 5 – Detector responses from injection of tracer into ammonia converter.

This test proved that there was a leak in the internal exchanger. Additional detectors were mounted on the external exchanger. It was tested and proven to be operating without any leaks. Additional injections were made into each quench line to see if any tracer exited early, but none did. These tests proved that the only leak in the converter system was in the internal exchanger.
