Optimising Desalter Performance Is Just One of Tracerco's Specialties We Proudly Provide.

Case study: Desalter distribution study

Crude Vacuum Tower Wash Bed Optimisation

Applications Note – ThruVision™

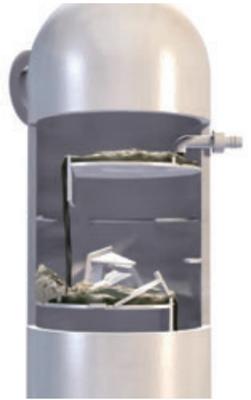
Figure 8 – Tru-Scan™ results decided the course of action for the refinery during their turnaround. Modifications to the tower were made instead of preparing to replace damaged trays which scan results found were not necessary.

The ΔP of the Depropanizer was higher than normal. Operations suspected flooding, probably as a result of some tray damage to the lower trays due to the high base liquid level. The scan results did show the high base liquid level covering the reboiler return nozzle. As a result of the reboiler return vapor mixing with the base liquid there was a lot of liquid entrainment below the bottom tray (Tray 1 in Figure 8). The bottom trays were flooding but had no apparent damage. These scan results decided the course of action for the refinery during the turnaround. Plans were made to modify piping so the reboiler would operate correctly with the proper base liquid level instead of purchasing trays when scan results indicated the existing trays were not damaged.
