MANAGING WASH BEDS

Gregory Cantley, Marathon Petroleum Company LP, USA, and Lowell Pless, Johnson Matthey Process Technology – Tracerco, USA, discuss a method to optimise the wash bed in crude vacuum towers.

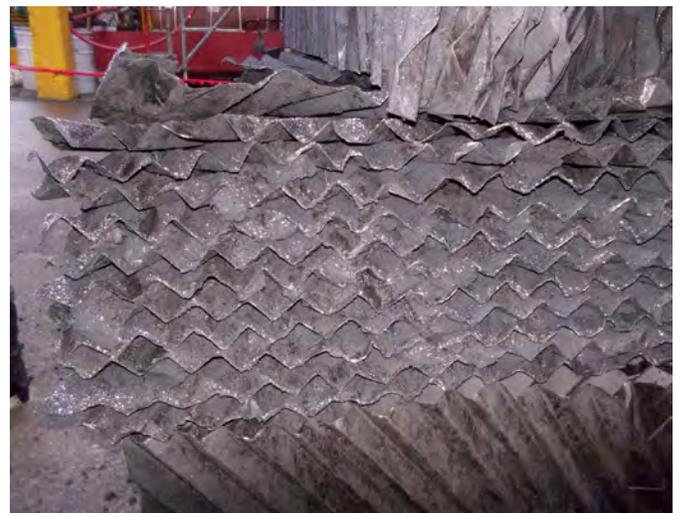
Figure 6. Picture of wash bed packing following Cycle 1 operation.

At the beginning of a cycle run, a baseline grid scan and tomography scan were carried out. Figure 3 shows the results from the baseline grid scan and Figure 4a shows the initial ThruVision scan results. Thereafter, the scans were repeated on a periodic basis, approximately every three months. The vacuum tower wash bed was operated very aggressively during the first cycle – minimum wash oil to maximise HVGO yield. This was purposely undertaken to set parameters for aggressive operation. The first section of the graph in Figure 5 shows the average wash bed densities calculated from the tomography scan data for Cycle 1. Figure 4b shows the ThruVision scan from the end of this cycle run. Over the two year period, there was a 40% increase in packing density due to coke build-up and/or excess liquid retention. After the two year period, there was an opportunity shutdown due to a problem that was unrelated to the coking. Subsequent shutdown and inspection showed the packing was severely fouled with coke (Figure 6) and so it was replaced.
