## Tracer Technology Provides Insight Into Leaking Trays And Entrainment

By Lowell Pless – Business Dev. Mgr – Distillation Applications and Dave Ferguson – Business Dev. Mgr – Tracer Technology

# TRACERCO Diagnostics™ Tower Scan Field Testing and Process/Hydraulic Analysis Revealed Likely Causes of Flooding Problems in a High Pressure Depropaniser

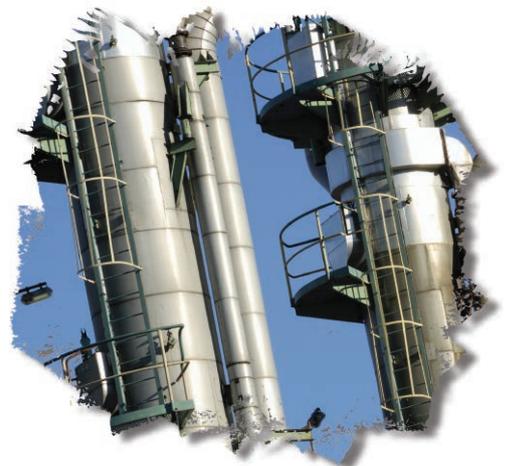
A Wash Bed tray was tested by injecting a specialist tracer into the Wash Oil feed that would not vapourise (Figure 1). The specialist tracer was selected based upon the very hot conditions encountered within the process and the instability and hence unsuitability of any organic based radiotracer material. Detectors 1 and 2 were positioned on the Wash Oil line to measure the flow to the Wash Oil spray

header. Detector 3 was on the Slop Wax line, which is the draw from the Wash Bed tray, and was used to determine the amount of tracer that flowed from the Slop Wax draw tray. Detectors 4 and 5 on the HVGO draw line were used to confirm the flow from the HVGO draw tray. Detectors 6, 7, and 8 on the Vacuum Tower Bottoms (VTB) line were used for monitoring for the presence or absence of a leak.

Figure 1 – Illustration of detector placement
