PackView™ – quantitative analysis of packing mal-distribution

Enhanced quantitative analysis of Tracerco Diagnostics™ Scan results

Tracerco assists a large LNG facility experiencing problems within their slug catcher

Tracerco™ ThruVision scan detects mechanical problems with a mist eliminator pad

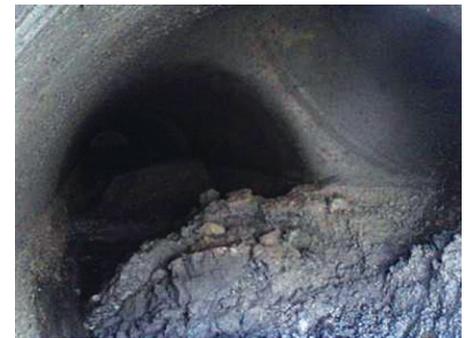
Figure 15 – Internal photo showing a view of the extent of fouling within the Slug Catcher.

Based upon the scan results the customer now understood the severity of fouling within the Slug Catcher. The photo in Figure 15 shows the degree of fouling found.
