Tracer Technology Provides Insight Into Leaking Trays And Entrainment

By Lowell Pless – Business Dev. Mgr – Distillation Applications
and Dave Ferguson – Business Dev. Mgr – Tracer Technology

TRU-SCAN® Field Testing and Process/Hydraulic Analysis Revealed Likely Causes of Flooding Problems in a High Pressure Depropanizer

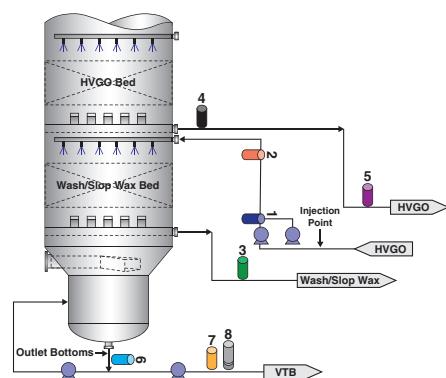
Figure 1 – Illustration of detector placement

A Wash Bed tray was tested by injecting a specialist tracer into the Wash Oil feed that would not vaporize (Figure 1). The specialist tracer was selected based upon the very hot conditions encountered within the process and the instability and hence unsuitability of any organic based radio-tracer material. Detectors 1 and 2 were positioned on the Wash Oil line to measure the flow to the Wash Oil spray header. Detector 3 was on the Slop Wax
