Tracer Technology Provides Insight Into Leaking Trays And Entrainment

By Lowell Pless – Business Dev. Mgr – Distillation Applications and Dave Ferguson – Business Dev. Mgr – Tracer Technology

TRACERCO Diagnostics™ Tower Scan Field Testing and Process/Hydraulic Analysis Revealed Likely Causes of Flooding Problems in a High Pressure Depropaniser

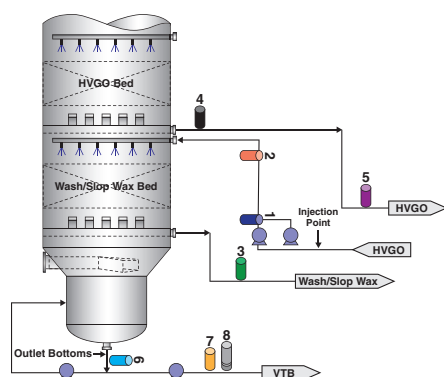
A Wash Bed tray was tested by injecting a specialist tracer into the Wash Oil feed that would not vapourise (Figure 1). The specialist tracer was selected based upon the very hot conditions encountered within the process and the instability and hence unsuitability of any organic based radiotracer material. Detectors 1 and 2 were positioned on the Wash Oil line to measure the flow to the Wash Oil spray

Figure 1 – Illustration of detector placement
