Packed Column - Distribution

Project Field Test

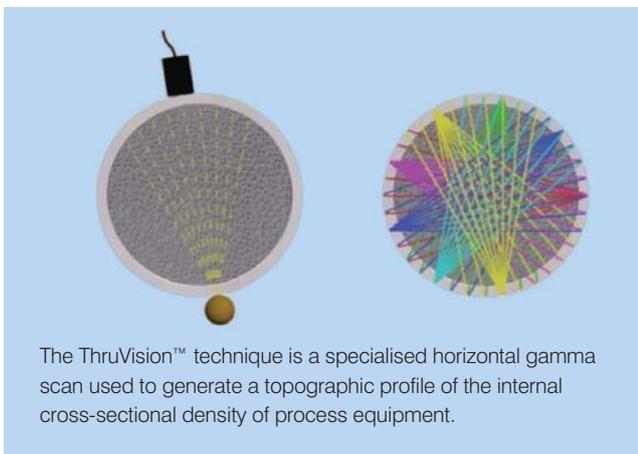
The Tracerco ThruVision™ Scan results (Figure 2) showed that a large amount of liquid was channeling down through the centre of the bed. This was not detected by a Tru-Grid™ Scan due to its pattern as all chords showed similar density profiles. This confirmed that a liquid maldistribution problem, rather than poor packing performance, was the cause of the efficiency reduction in the tower.
